Arborists Report and Tree Inventory

**Rialto Place Project Site
Somerville Road
Parcel 076-010-032, -034, -036 & -037
Antioch, CA**

April 18, 2024

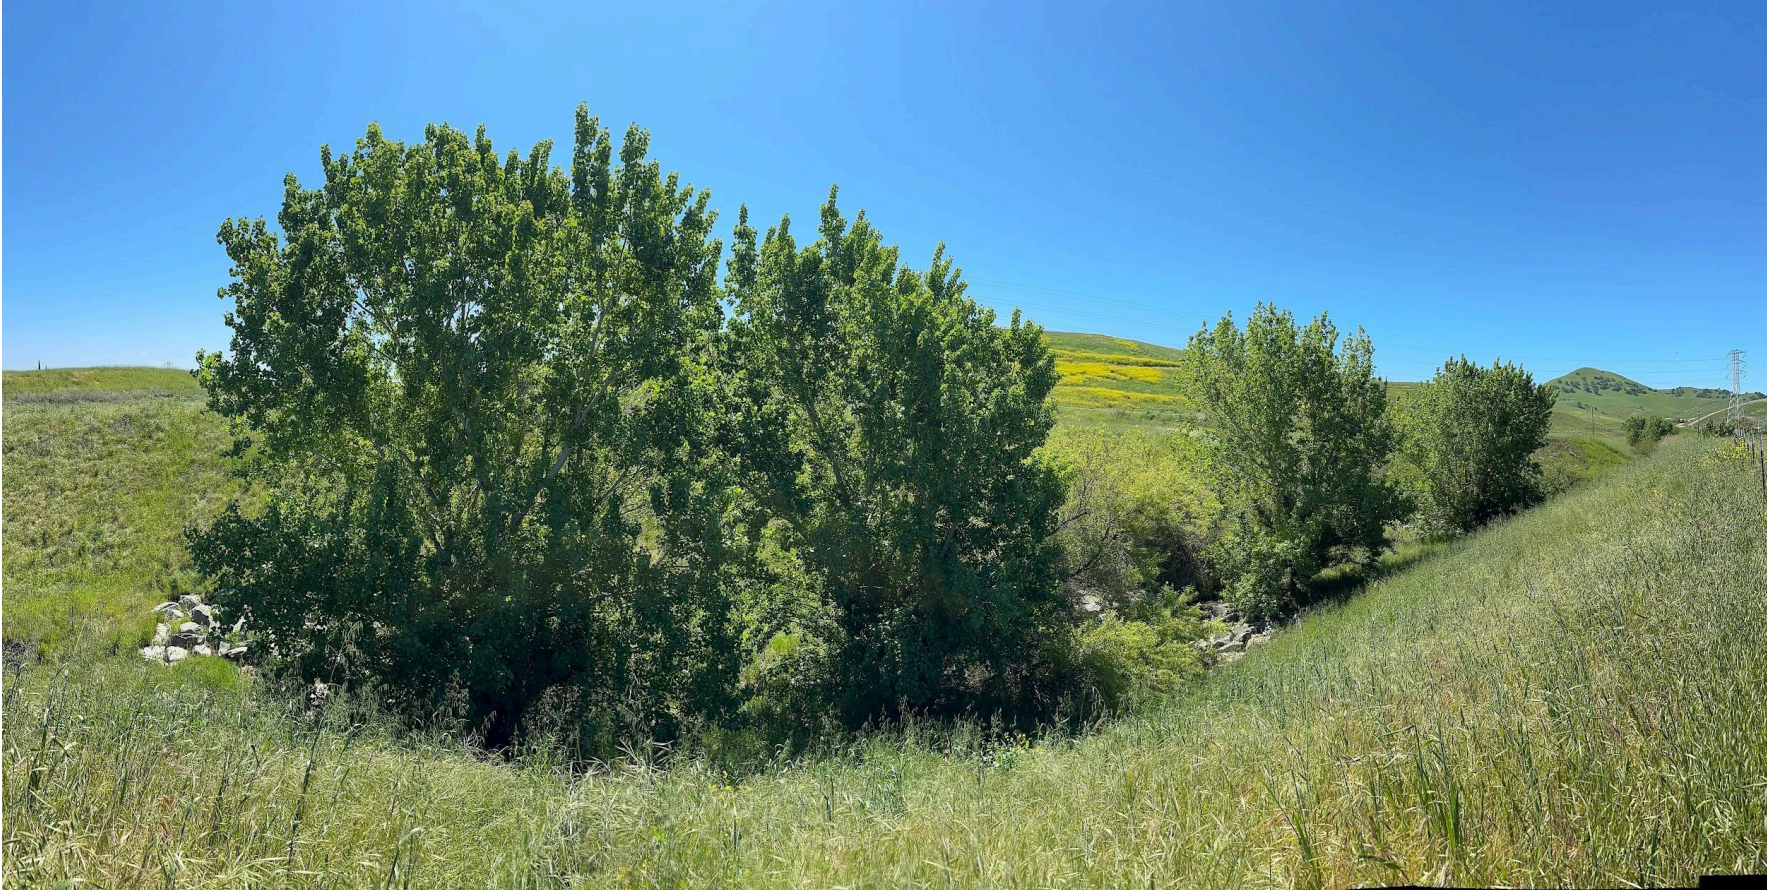
Photo #1, Shows Trees #4894 (left) and trees between #4900 (far right).

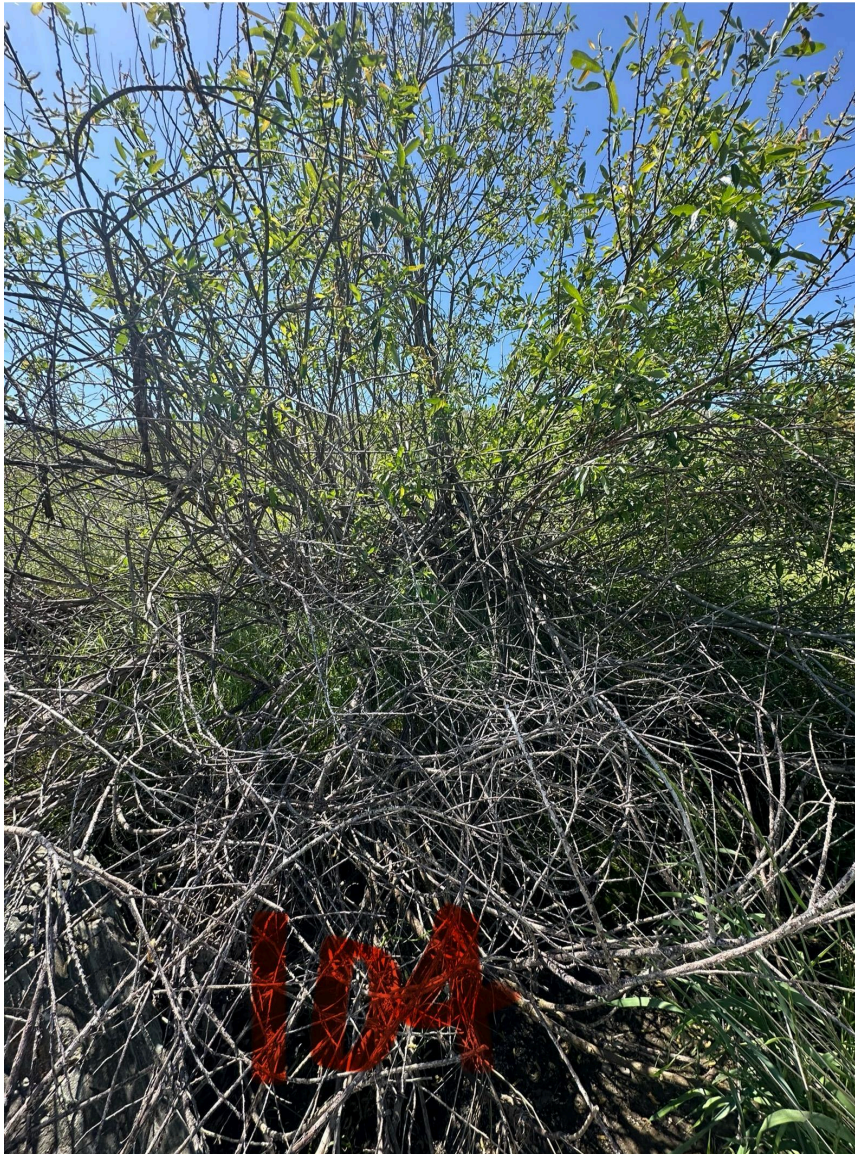
Photo #2, Shows Tree #104. All trees with a virtual number did not have a stem large enough for a physical tag.

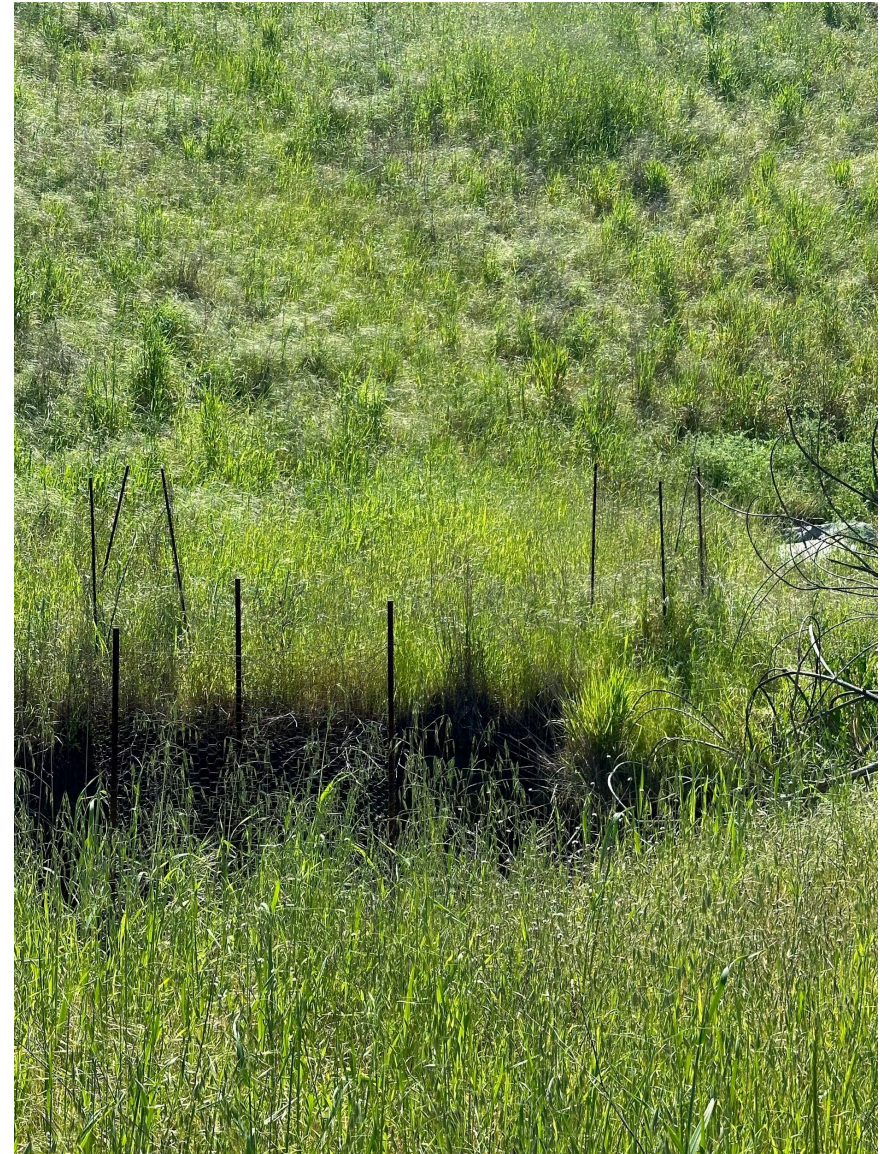
The ravine was vegetated but many of the planted trees are dead. Some of the trees (included within this report) still have wire around the trunk which is negatively affecting those trees.

Photo #3, The site appears to have been revegetated. There are many planting locations with no live trees. These locations are not shown on The map or included in the data.

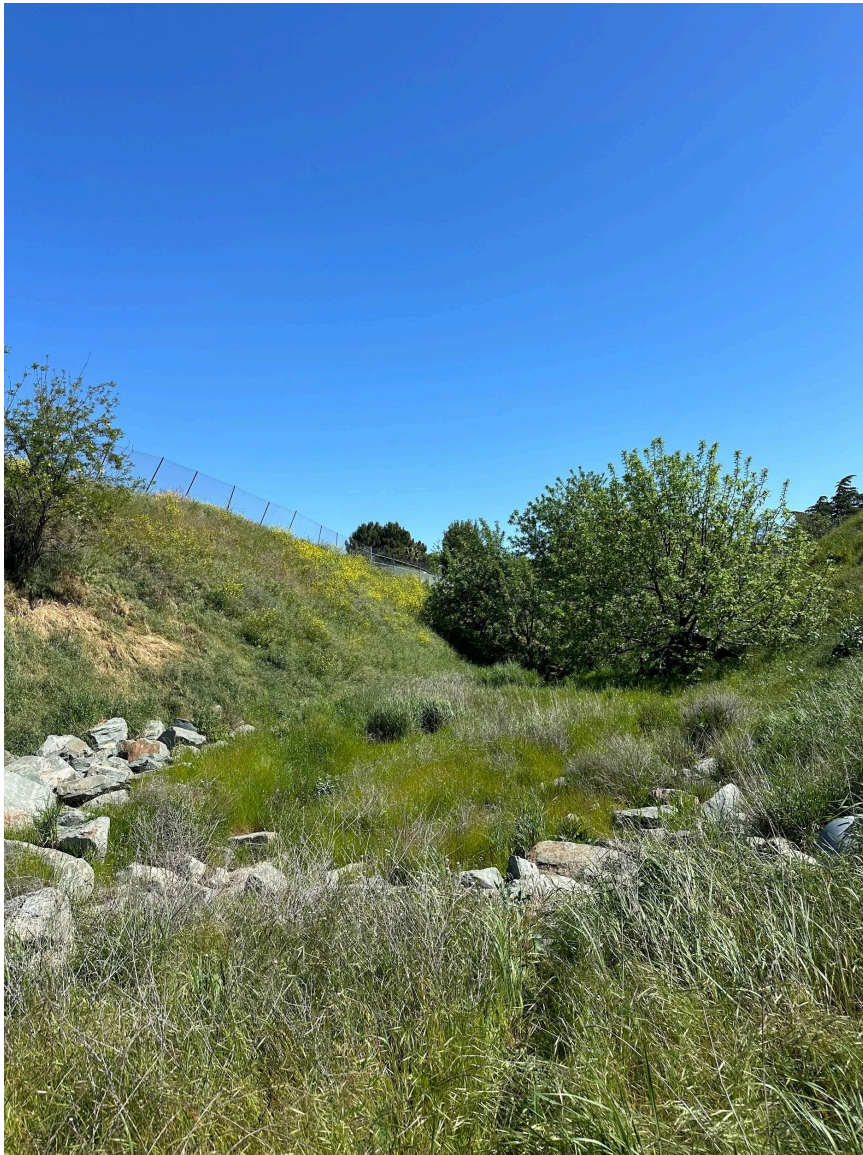
Photo #4, Looking approximately northeast. Tree #103 on the left appears to be on the site. The other trees on the right are offsite.

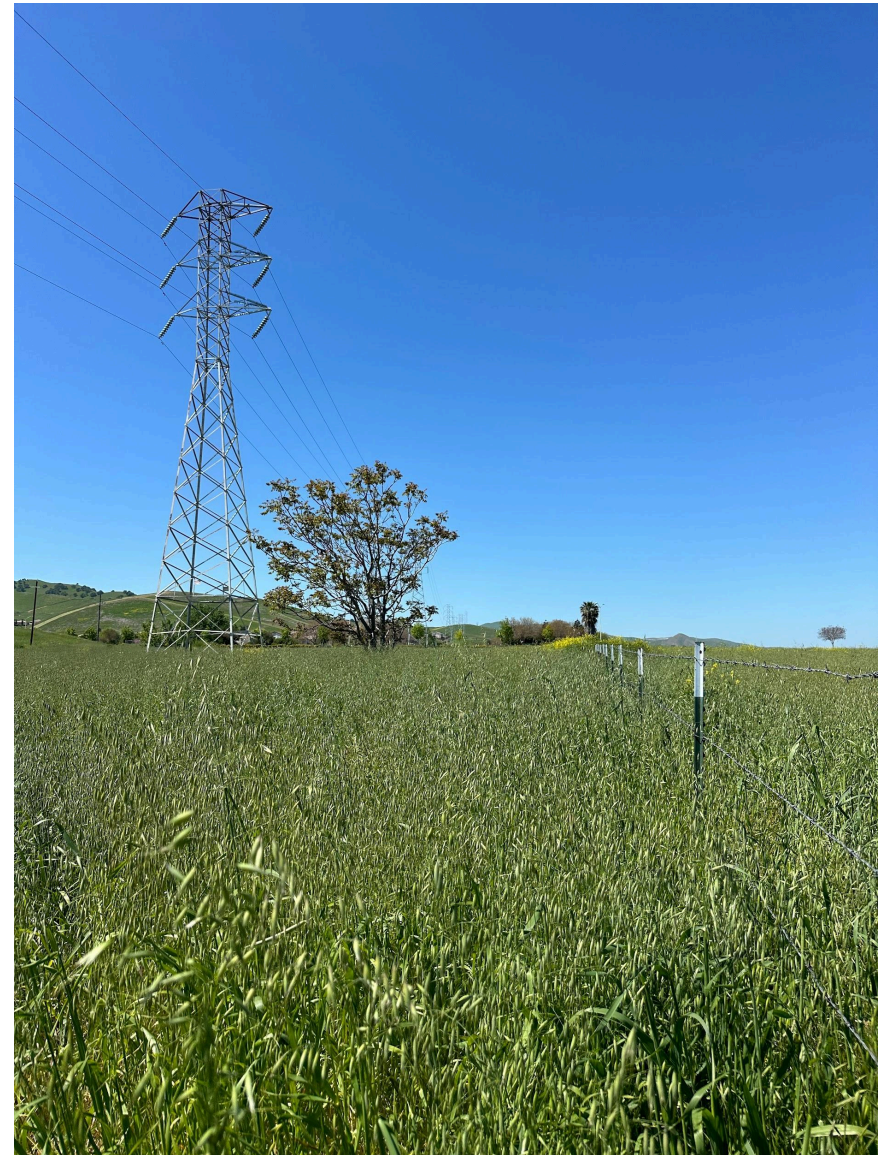
Photo #5, Looking approximately west down the property line. The offsite tree has adequate space and was not included in the inventory.
